Learn from the mistakes of others; you'll not live long enough to make them all yourself . . . Issue 3/2004

When Night VFR and IFR Collide

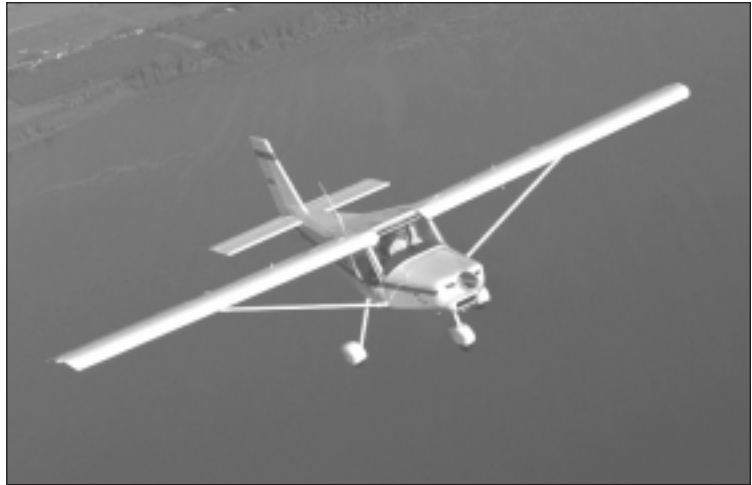
The amphibious amateur-built aircraft was made of fibreglass and had been sitting at a local airport for several years, when it was put up for sale. An aircraft mechanic purchased it, inspected the structure as best he could, made repairs, and put it up for re-sale. He soon found a buyer who was hoping that the amphibious abilities of the aircraft would allow him to fly from his home airport to the numerous good fishing spots that abounded in the northern region of Canada, where he lived. The aircraft was ferried successfully to the new owner's home-base where an inspection was carried out and the transaction completed. The new owner was given flight instructions and later went off by himself to do a fly-by. During this flight, one of the wings failed and the aircraft plummeted to the ground, killing him. Investigation by the Transportation Safety Board (TSB) revealed that one of the wing's integral fibreglass fuel tanks had delaminated and allowed fuel to seep through and weaken the wing spar to a point where failure occurred. This construction flaw had gone unnoticed for some time and the wing deteriorated and failed.

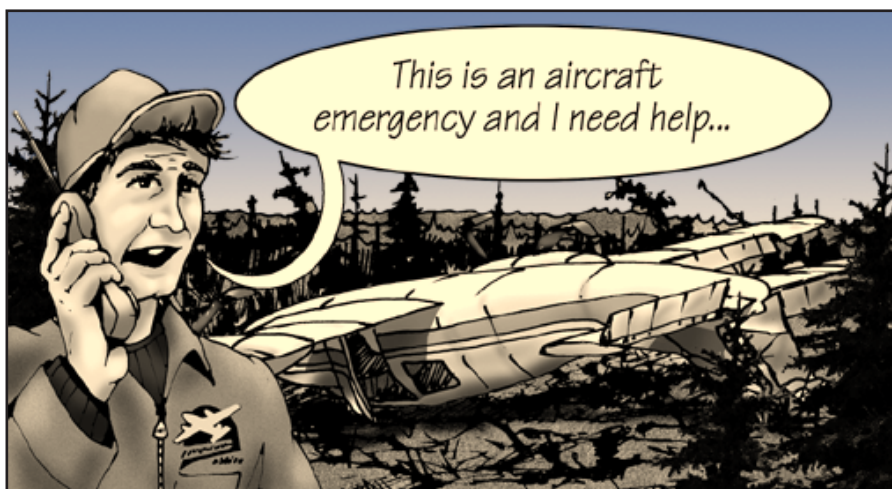
On August 17, 2003, Mr. Laplante and a friend were flying in Northern Labrador in his Cessna 172 on floats, exploring fjords and lakes, and planning to meet two more friends in a separate aircraft at a rendez-vous point for a few days of camping and flying. Having arrived early at the rendez-vous point, Mr. Laplante and his friend decided to fly 10 to 12 mi. further north to Kangalaksiorvik Lake, to film known wildlife at that location. They landed safely on the lake and spent a half-hour filming seals and other wildlife. Unfortunately for them, the wind started to pick-up significantly, and the waves were causing some serious handling difficulties. While attempting to manoeuvre the aircraft back into wind for departure, a float dug in, and in very short order, the aircraft had overturned in shallow water, giving them just enough time to exit and inflate their life jackets.
